Methamphetamine FC Screening Assessment Report

Address inspected: 1-179 Kilkenny Dr, East Tamaki, Auckland

Date of Inspection: 23/09/2020 Time: 12:30pm

Test type: Field Composite (FC) Swab Screening Test - no. of sample kits = ONE				
Conclusion: Screening result was negative for methamphetamine, indicating that no further testing is necessary. PROPERTY MEETS NZ STANDARDS - NO METH DETECTED.				
Property description: single level residential house, internal garage.				
Sample Kit 1	Location	Photo	Result	
1 House & garage	All rooms sampled.	Yes	NEGATIVEµg Field Composite Screening tests combine the level of the rooms tested.	
2				
3	See pics for exact locations.			
4	Total locations swabbed = 10	Yes

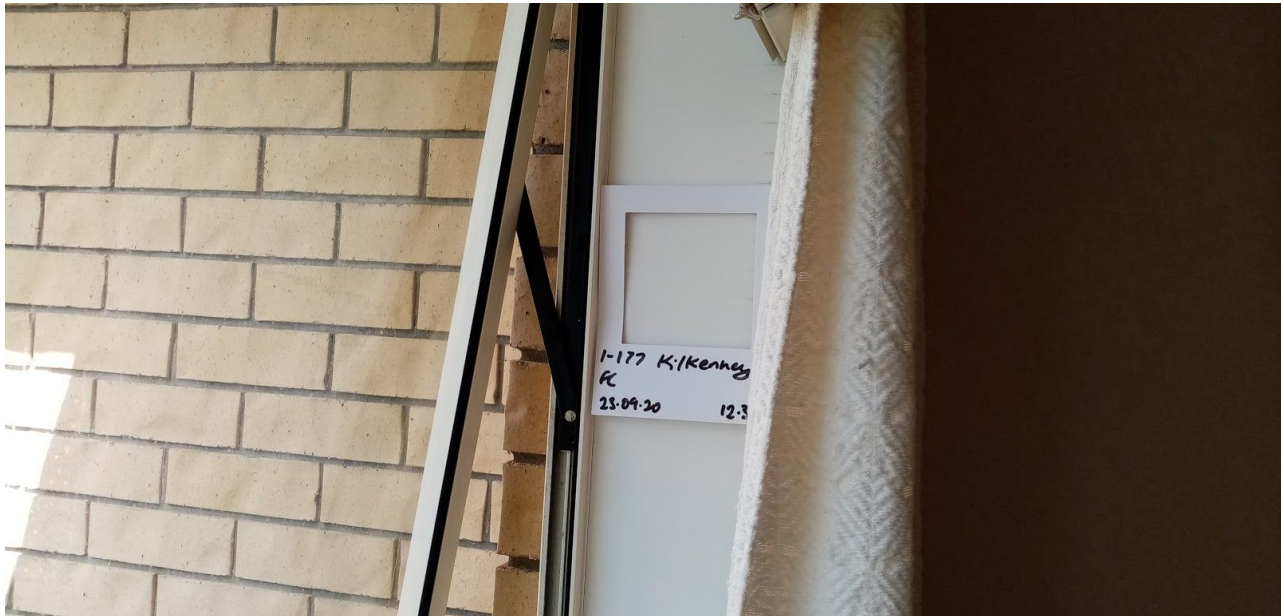
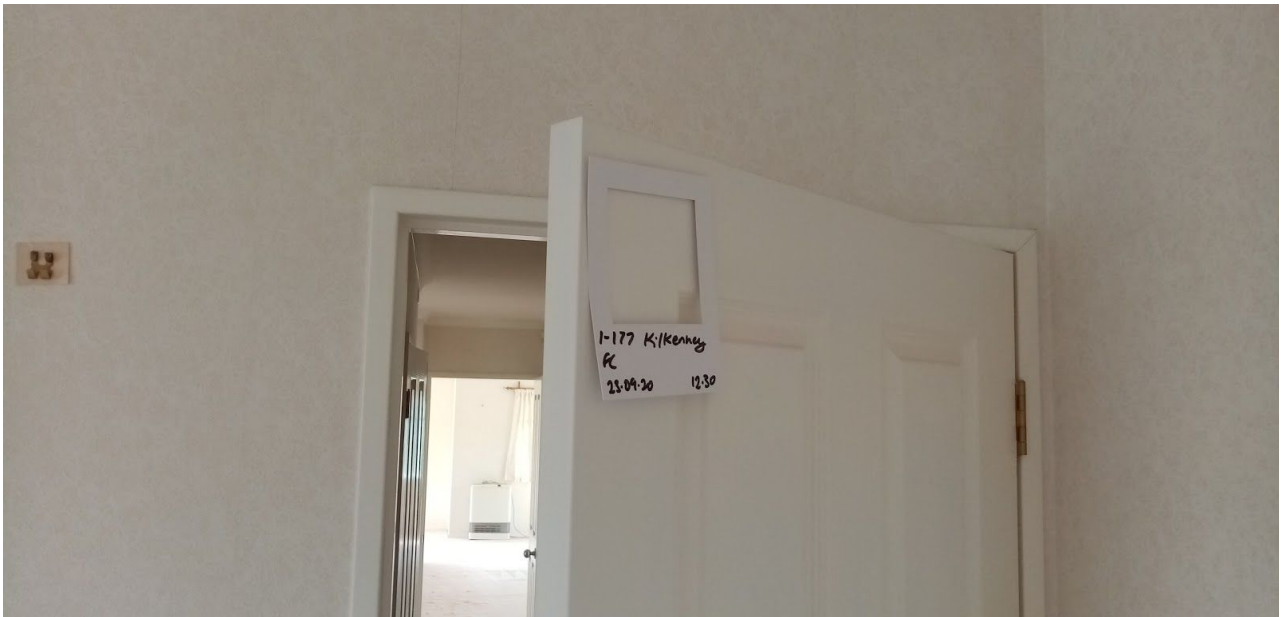
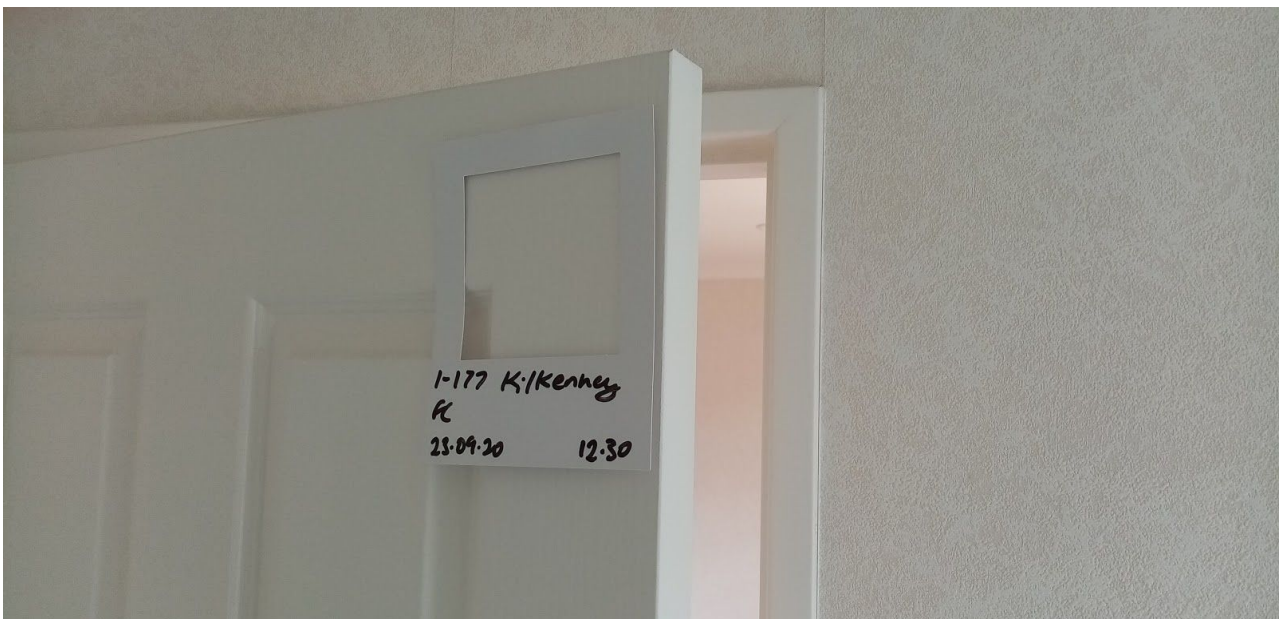
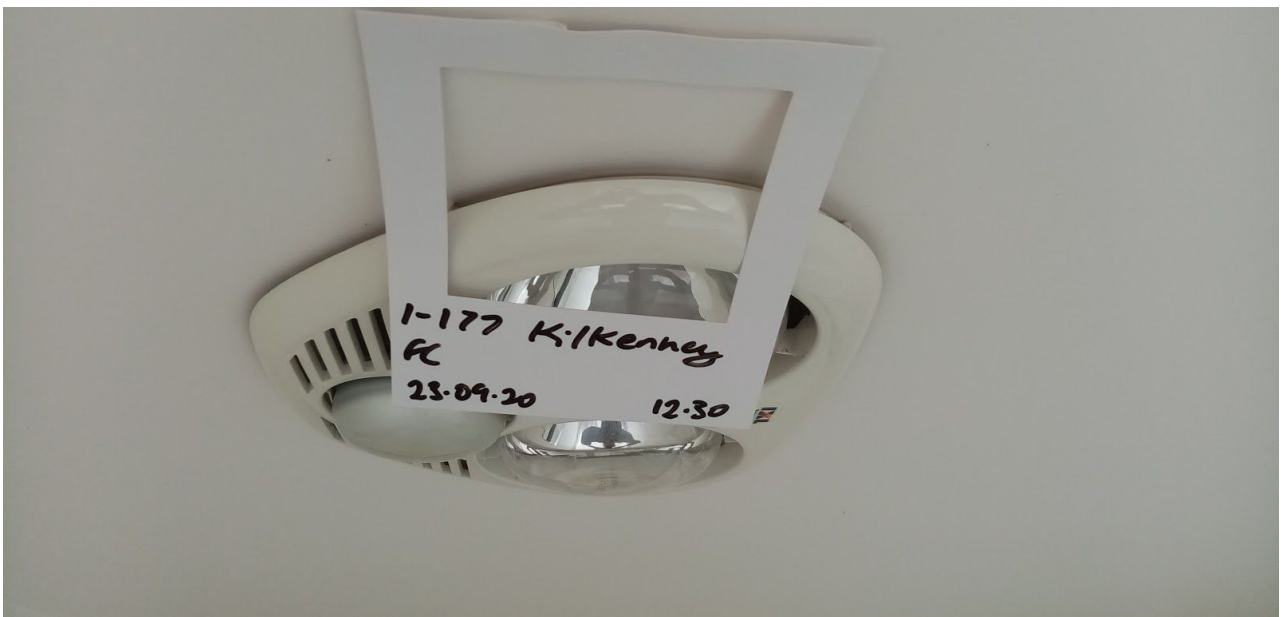
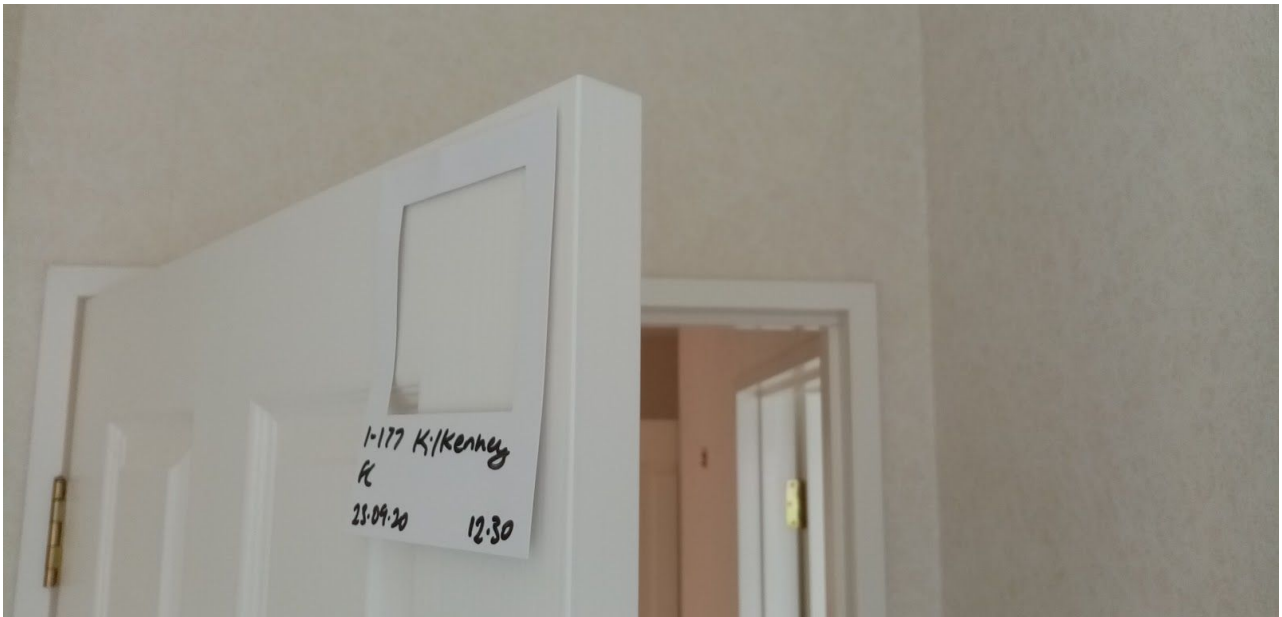
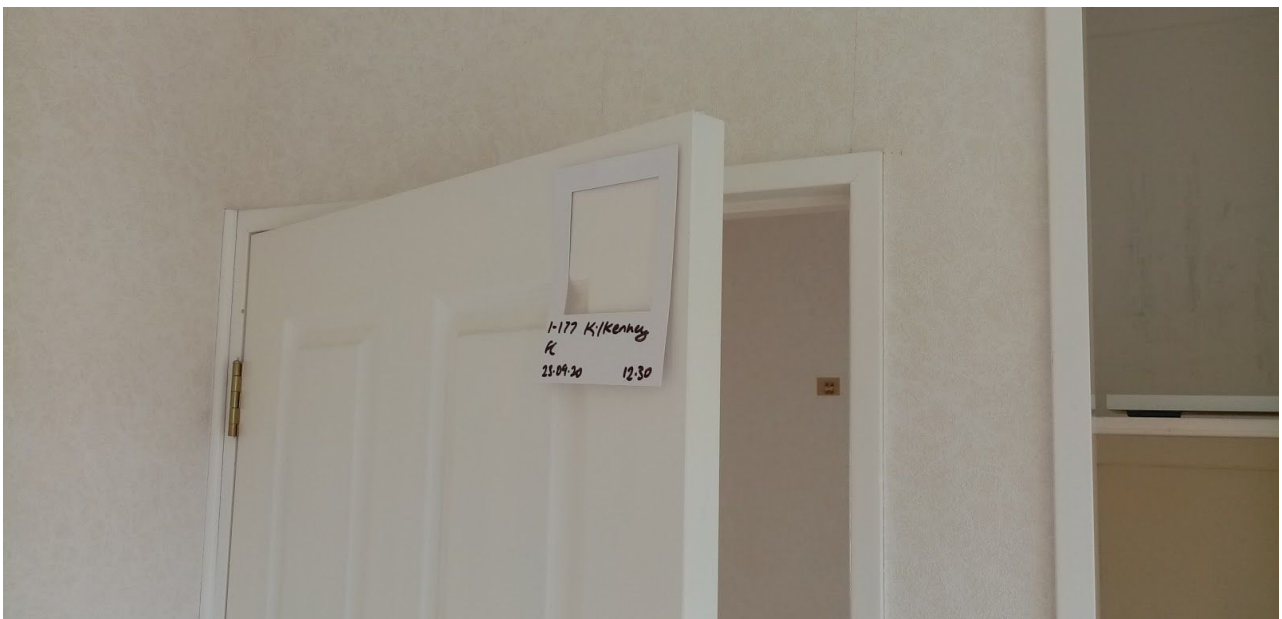
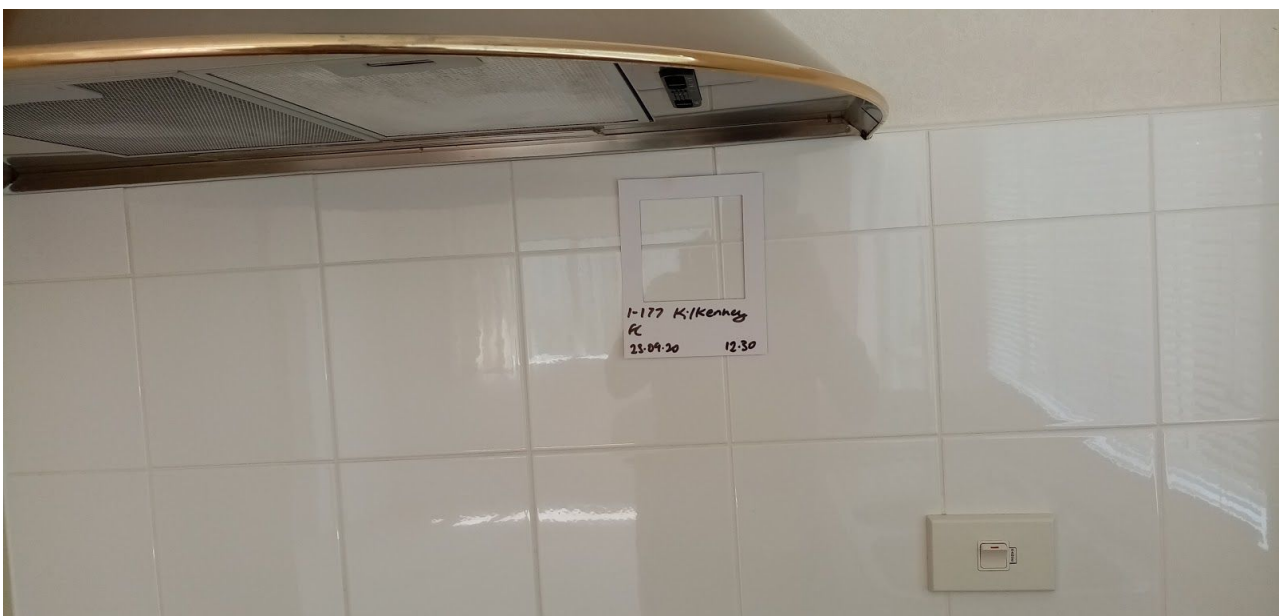
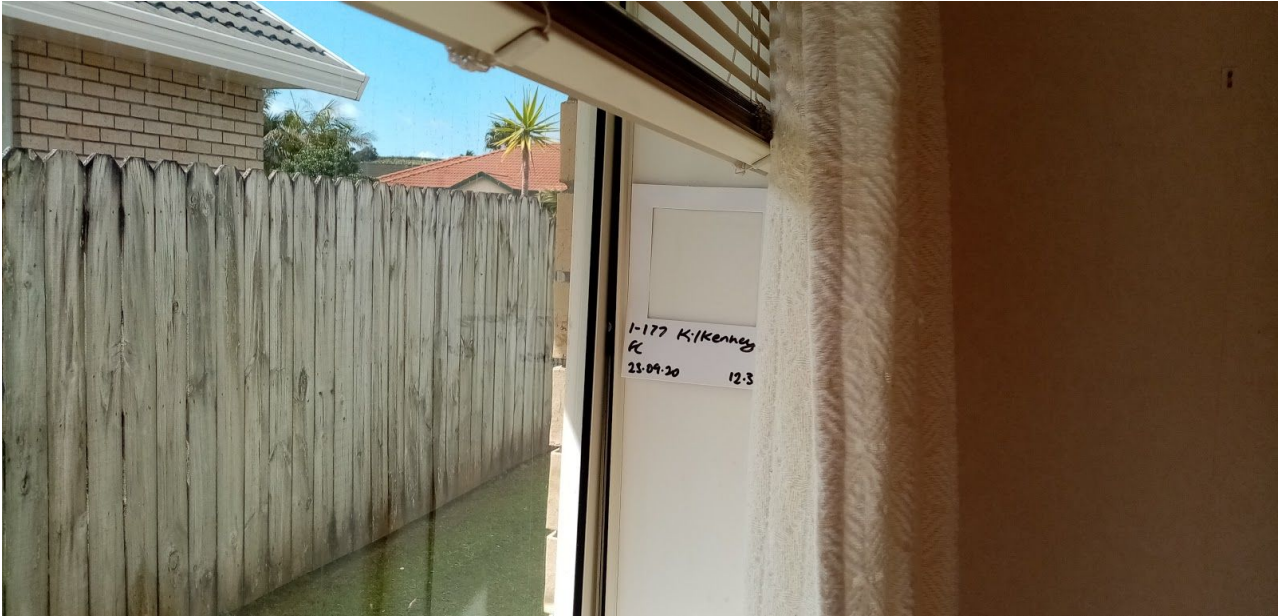
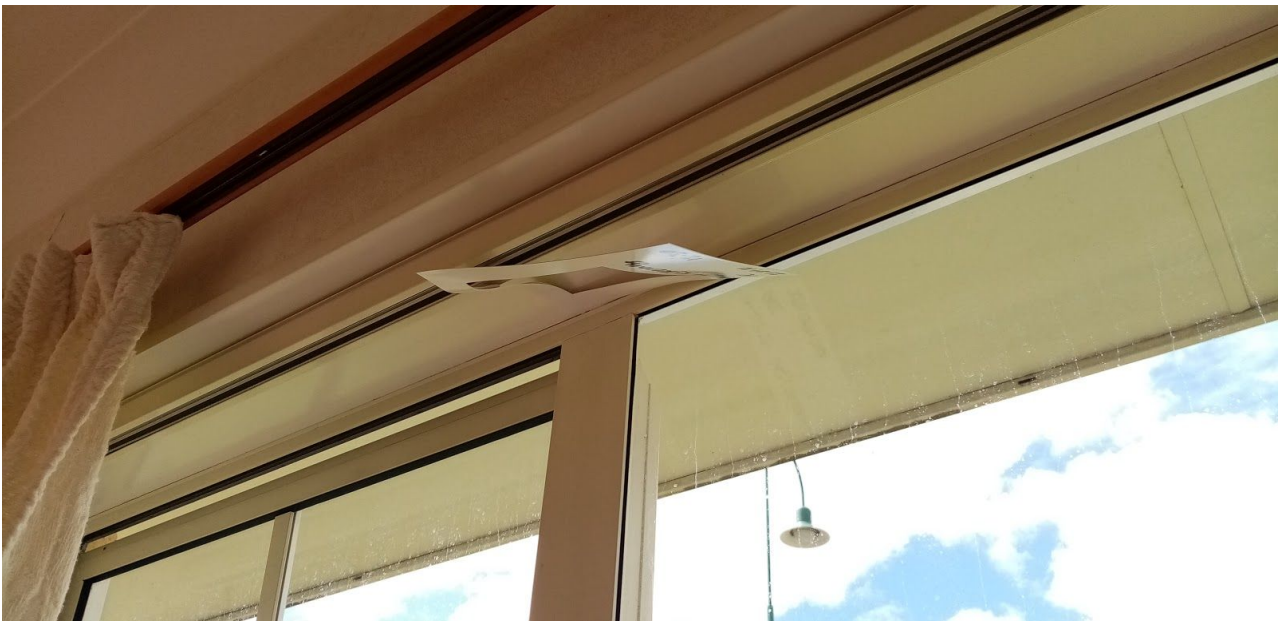
Pictures are for reference if further testing or other evaluation needed.

Photos and samples usually taken in a clockwise direction around house, starting in kitchen.

Samples were collected in **all** rooms.
